**Report of Noise, Dust, and Blasting Monitoring
Vulcan Materials Company
Maryville Quarry**

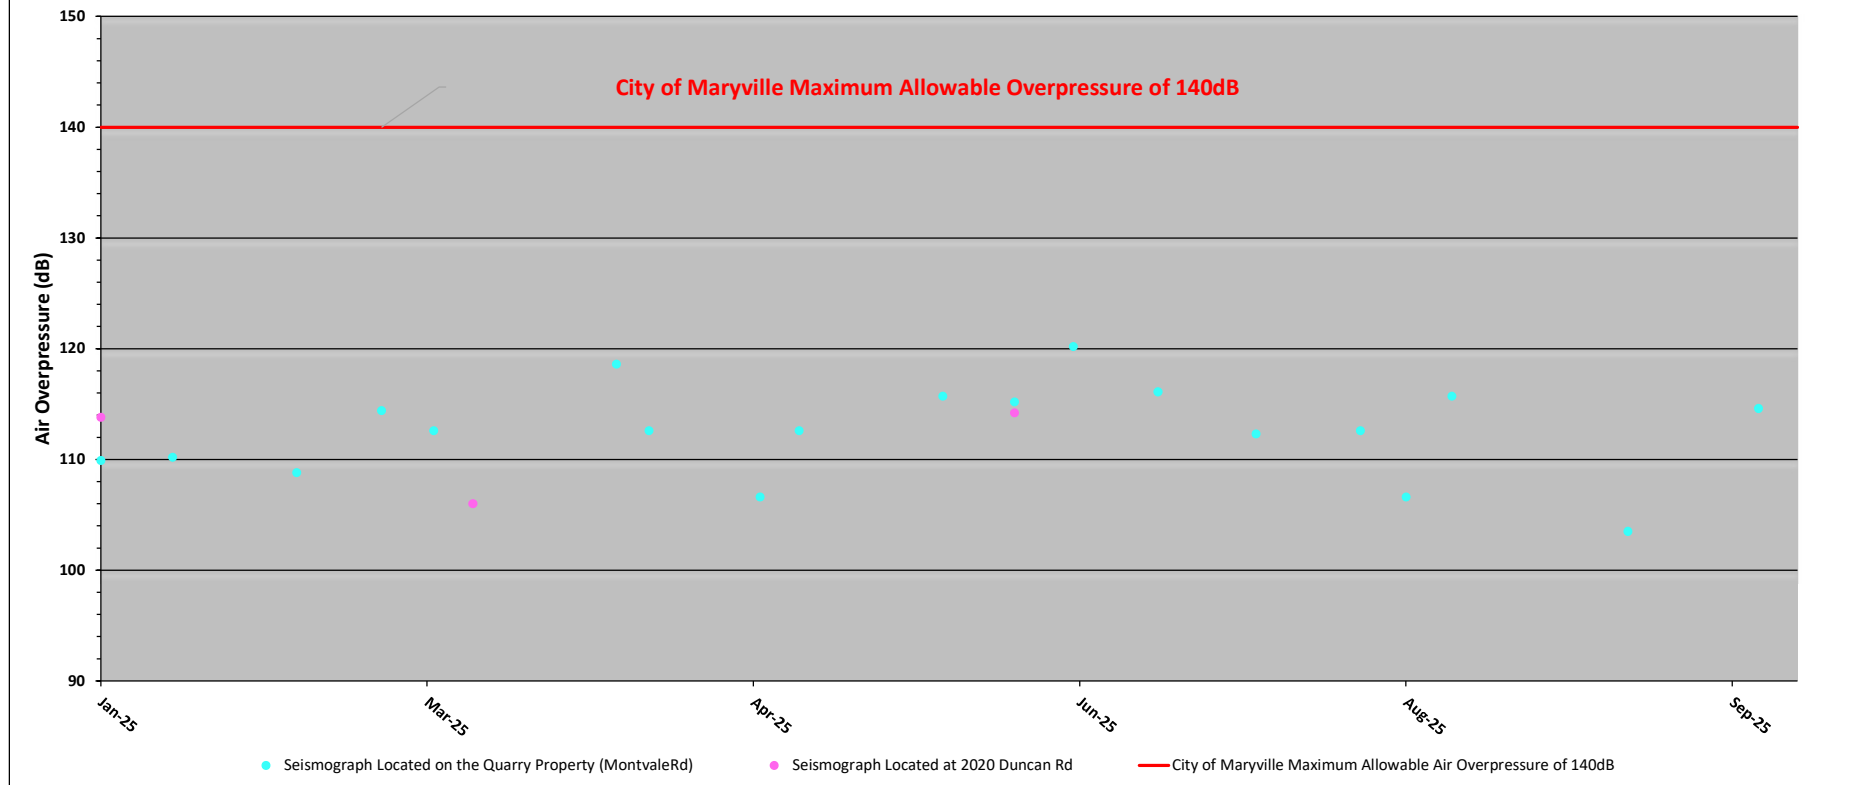
Maryville Quarry Blasting 2025

Blast Date	Time	Seismograph Located on the Quarry Property (MontvaleRd)		Seismograph Located at 2020 Duncan Rd	
		PPV	dB	PPV	dB
1/13/2025	16:16	0.055	109.9	0.04	113.8
1/24/2025	11:23	0.065	110.2	NT	NT
1/31/2025	11:06	NT	NT	NT	NT
2/7/2025	12:23	NT	NT	NT	NT
2/12/2025	11:48	0.055	108.8	NT	NT
2/25/2025	12:50	0.035	114.4	NT	NT
2/28/2025	11:28	NT	NT	NT	NT
3/5/2025	12:14	0.05	112.6	NT	NT
3/11/2025	14:21	NT	NT	0.04	106
3/14/2025	14:25	NT	NT	NT	NT
3/24/2025	14:09	NT	NT	NT	NT
4/2/2025	12:06	0.06	118.6	NT	NT
4/7/2025	13:06	0.065	112.6	NT	NT
4/24/2025	12:30	0.075	106.6	NT	NT
4/30/2025	13:34	0.055	112.6	NT	NT
5/9/2025	13:34	NT	NT	NT	NT
5/13/2025	14:09	NT	NT	NT	NT
5/22/2025	13:10	0.045	115.7	NT	NT
6/2/2025	15:23	0.04	115.2	0.035	114.2
6/11/2025	12:19	0.04	120.2	NT	NT
6/24/2025	11:49	0.06	116.1	NT	NT
7/9/2025	17:18	0.075	112.3	NT	NT
7/25/2025	10:33	0.04	112.6	NT	NT
8/1/2025	11:52	0.05	106.6	NT	NT
8/8/2025	12:05	0.035	115.7	NT	NT

8/25/2025	12:33	NT	NT	NT	NT
9/4/2025	12:28	0.06	103.5	NT	NT
9/24/2025	16:18	0.05	114.6	NT	NT

*N/T = Seismograph not triggered (PPV levels below detection level of seismograph)
