Report of Noise, Dust, and Blasting Monitoring
 Vulcan Materials Company
 Maryville Quarry

2023 Maryville Quarry Blasting Monitoring

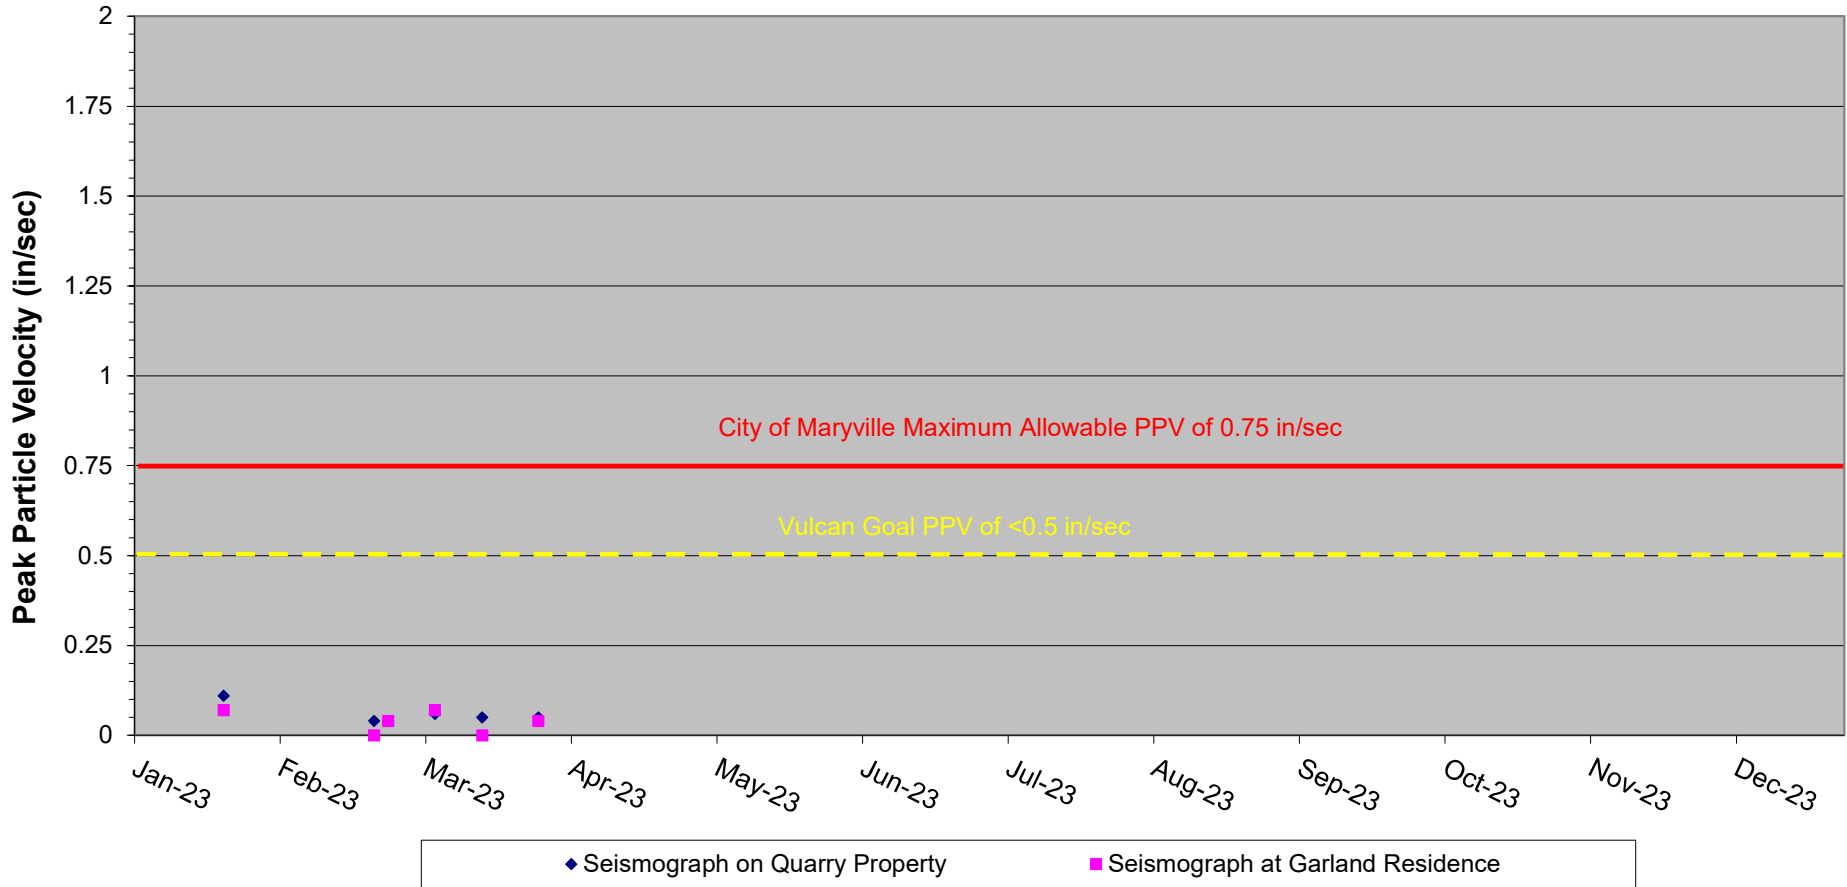
Maryville Quarry Blasting 2023

Blast Date	Time	Seismograph Located on the Quarry Property (MontvaleRd)		Seismograph Located at 2020 Duncan Rd	
		PPV	dB	PPV	dB
1/20/23	15:37	0.11	120	0.07	124
2/21/23	14:31	0.04	102	NT	NT
2/24/23	12:59	0.04	110	0.04	103
3/6/23	15:06	0.06	118	0.07	117
3/16/23	14:49	0.05	110	NT	NT
3/28/23	12:35	0.05	112	0.04	114
