Report of Noise, Dust, and Blasting Monitoring
 Vulcan Materials Company
 Maryville Quarry

2021 Maryville Quarry Blasting Monitoring

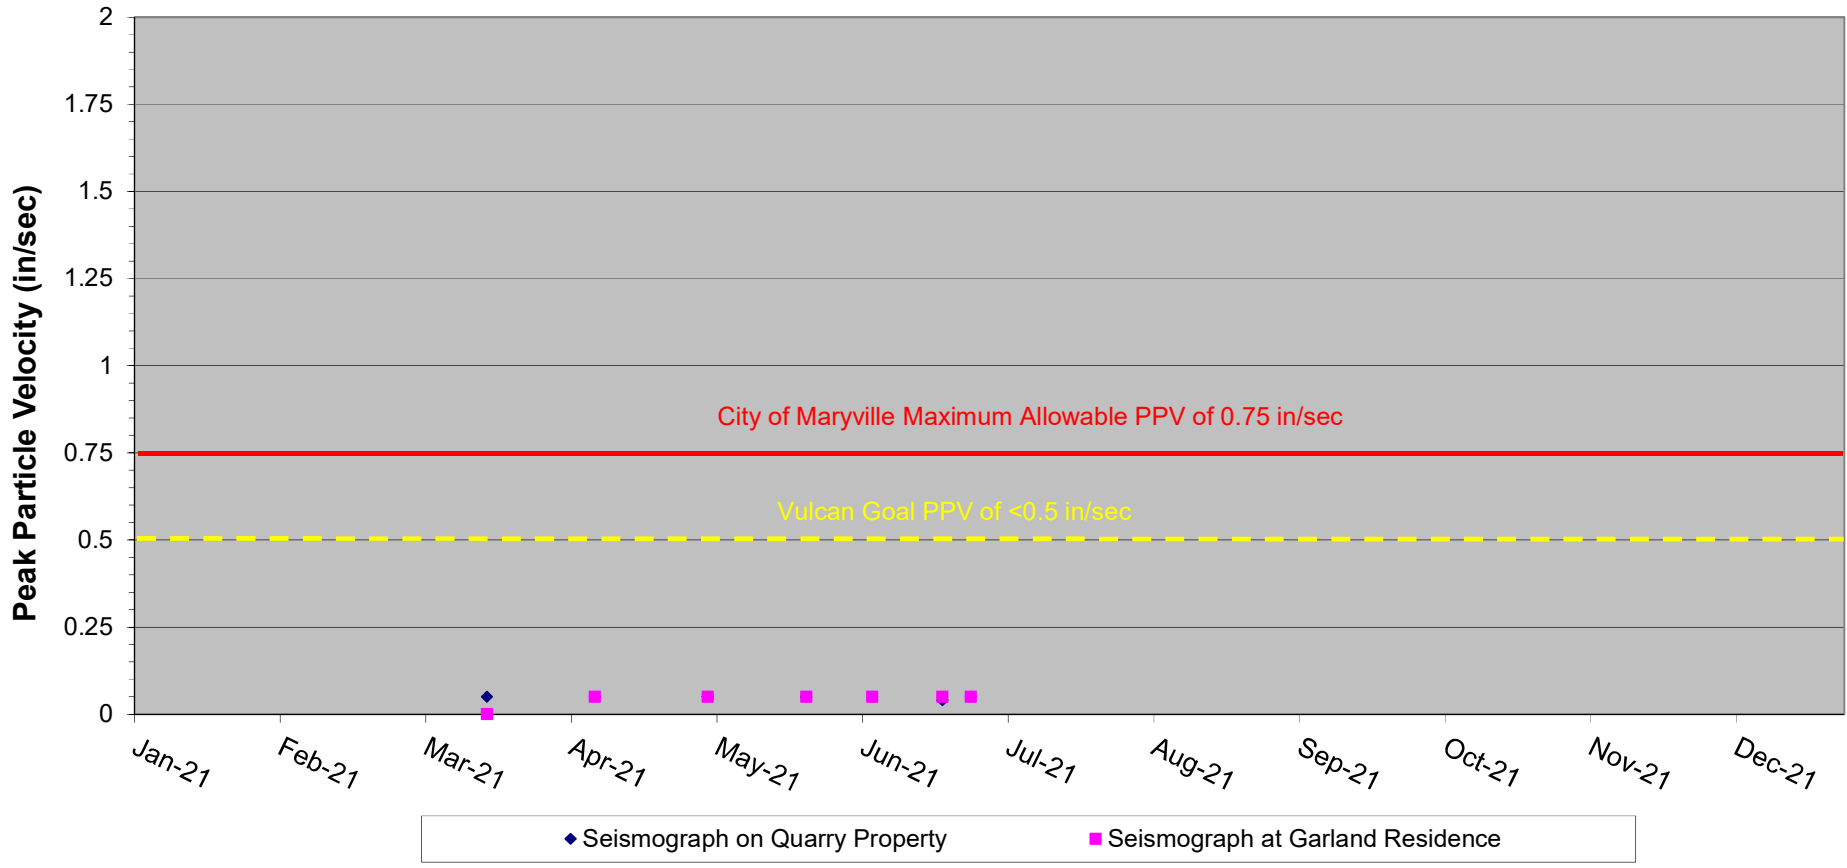
Maryville Quarry Blasting 2021

Blast Date	Time	Seismograph Located on the Quarry Property (MontvaleRd)		Seismograph Located at the Gardner Residence	
		PPV	dB	PPV	dB
3/17/21	11:28	0.05	105	N/T	N/T
4/9/21	13:14	0.05	107	0.05	110
5/3/21	12:42	0.05	106	0.05	114
5/24/21	12:50	0.05	100	0.05	110
6/7/21	11:57	0.05	108	0.05	111
6/22/21	11:12	0.04	106	0.05	108
6/28/21	12:48	0.05	108	0.05	115
