**Report of Noise, Dust, and Blasting Monitoring
Vulcan Materials Company
Maryville Quarry**

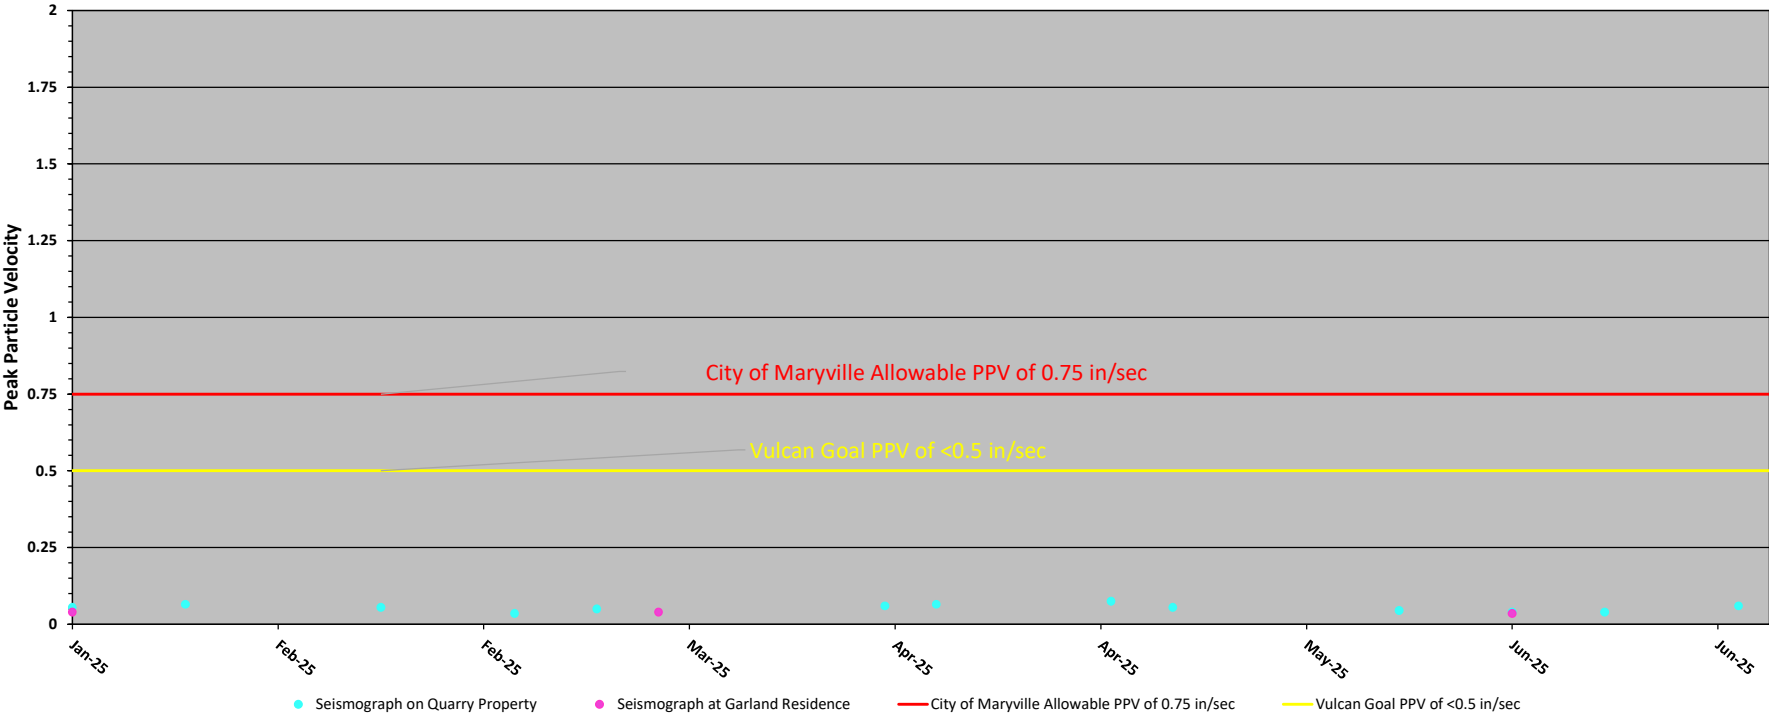
Maryville Quarry Blasting 2025

Blast Date	Time	Seismograph Located on the Quarry Property (MontvaleRd)		Seismograph Located at 2020 Duncan Rd	
		PPV	dB	PPV	dB
1/13/2025	16:16	0.055	109.9	0.04	113.8
1/24/2025	11:23	0.065	110.2	NT	NT
1/31/2025	11:06	NT	NT	NT	NT
2/7/2025	12:23	NT	NT	NT	NT
2/12/2025	11:48	0.055	108.8	NT	NT
2/25/2025	12:50	0.035	114.4	NT	NT
2/28/2025	11:28	NT	NT	NT	NT
3/5/2025	12:14	0.05	112.6	NT	NT
3/11/2025	14:21	NT	NT	0.04	106
3/14/2025	14:25	NT	NT	NT	NT
3/24/2025	14:09	NT	NT	NT	NT
4/2/2025	12:06	0.06	118.6	NT	NT
4/7/2025	13:06	0.065	112.6	NT	NT
4/24/2025	12:30	0.075	106.6	NT	NT
4/30/2025	13:34	0.055	112.6	NT	NT
5/9/2025	13:34	NT	NT	NT	NT
5/13/2025	14:09	NT	NT	NT	NT
5/22/2025	13:10	0.045	115.7	NT	NT
6/2/2025	15:23	0.04	115.2	0.035	114.2
6/11/2025	12:19	0.04	120.2	NT	NT
6/24/2025	11:49	0.06	116.1	NT	NT
