**Report of Noise, Dust, and Blasting Monitoring
Vulcan Materials Company
Maryville Quarry**

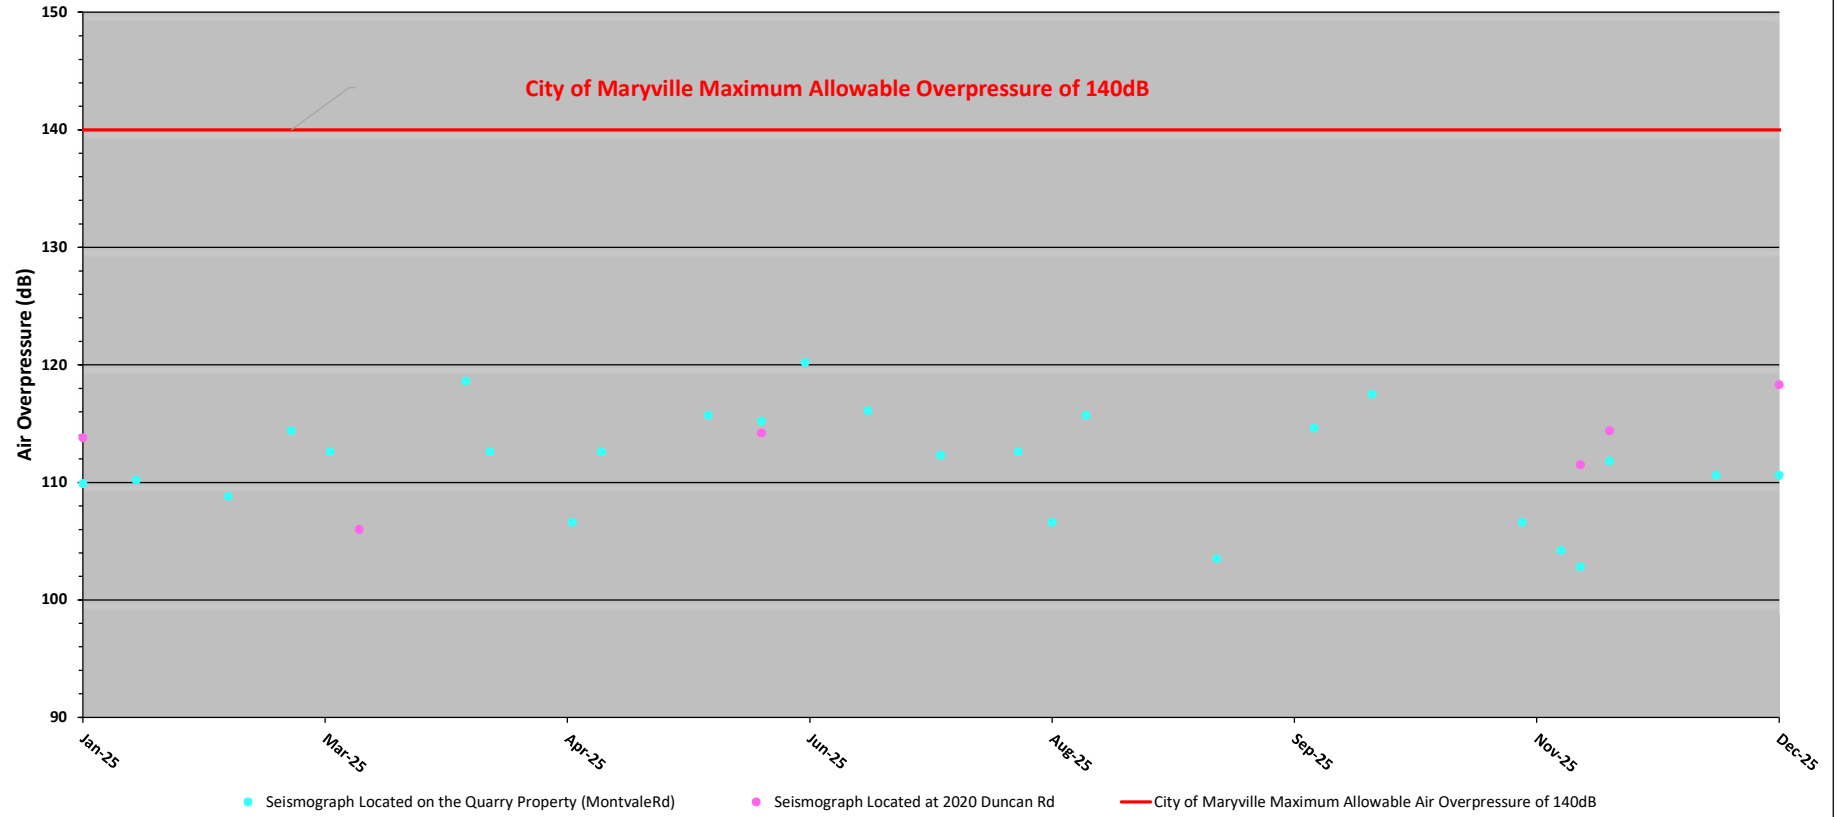
Maryville Quarry Blasting 2025

Blast Date	Time	Seismograph Located on the Quarry Property (MontvaleRd)		Seismograph Located at 2020 Duncan Rd	
		PPV	dB	PPV	dB
1/13/2025	16:16	0.055	109.9	0.04	113.8
1/24/2025	11:23	0.065	110.2	NT	NT
1/31/2025	11:06	NT	NT	NT	NT
2/7/2025	12:23	NT	NT	NT	NT
2/12/2025	11:48	0.055	108.8	NT	NT
2/25/2025	12:50	0.035	114.4	NT	NT
2/28/2025	11:28	NT	NT	NT	NT
3/5/2025	12:14	0.05	112.6	NT	NT
3/11/2025	14:21	NT	NT	0.04	106
3/14/2025	14:25	NT	NT	NT	NT
3/24/2025	14:09	NT	NT	NT	NT
4/2/2025	12:06	0.06	118.6	NT	NT
4/7/2025	13:06	0.065	112.6	NT	NT
4/24/2025	12:30	0.075	106.6	NT	NT
4/30/2025	13:34	0.055	112.6	NT	NT
5/9/2025	13:34	NT	NT	NT	NT
5/13/2025	14:09	NT	NT	NT	NT
5/22/2025	13:10	0.045	115.7	NT	NT
6/2/2025	15:23	0.04	115.2	0.035	114.2
6/11/2025	12:19	0.04	120.2	NT	NT
6/24/2025	11:49	0.06	116.1	NT	NT
7/9/2025	17:18	0.075	112.3	NT	NT
7/25/2025	10:33	0.04	112.6	NT	NT
8/1/2025	11:52	0.05	106.6	NT	NT
8/8/2025	12:05	0.035	115.7	NT	NT

8/25/2025	12:33	NT	NT	NT	NT
9/4/2025	12:28	0.06	103.5	NT	NT
9/24/2025	16:18	0.05	114.6	NT	NT
10/6/2025	12:14	0.06	117.5	NT	NT
10/22/2025	15:37	NT	NT	NT	NT
11/6/2025	11:52	0.045	106.6	NT	NT
11/14/2025	11:45	0.035	104.2	NT	NT
11/18/2025	12:40	0.095	102.8	0.08	111.5
11/24/2025	12:57	0.035	111.8	0.04	114.4
12/16/2025	12:35	0.035	110.6	NT	NT
12/29/2025	13:33	0.095	110.6	0.145	118.3

*NT = Seismograph not triggered (PPV levels below detection level of seismograph)

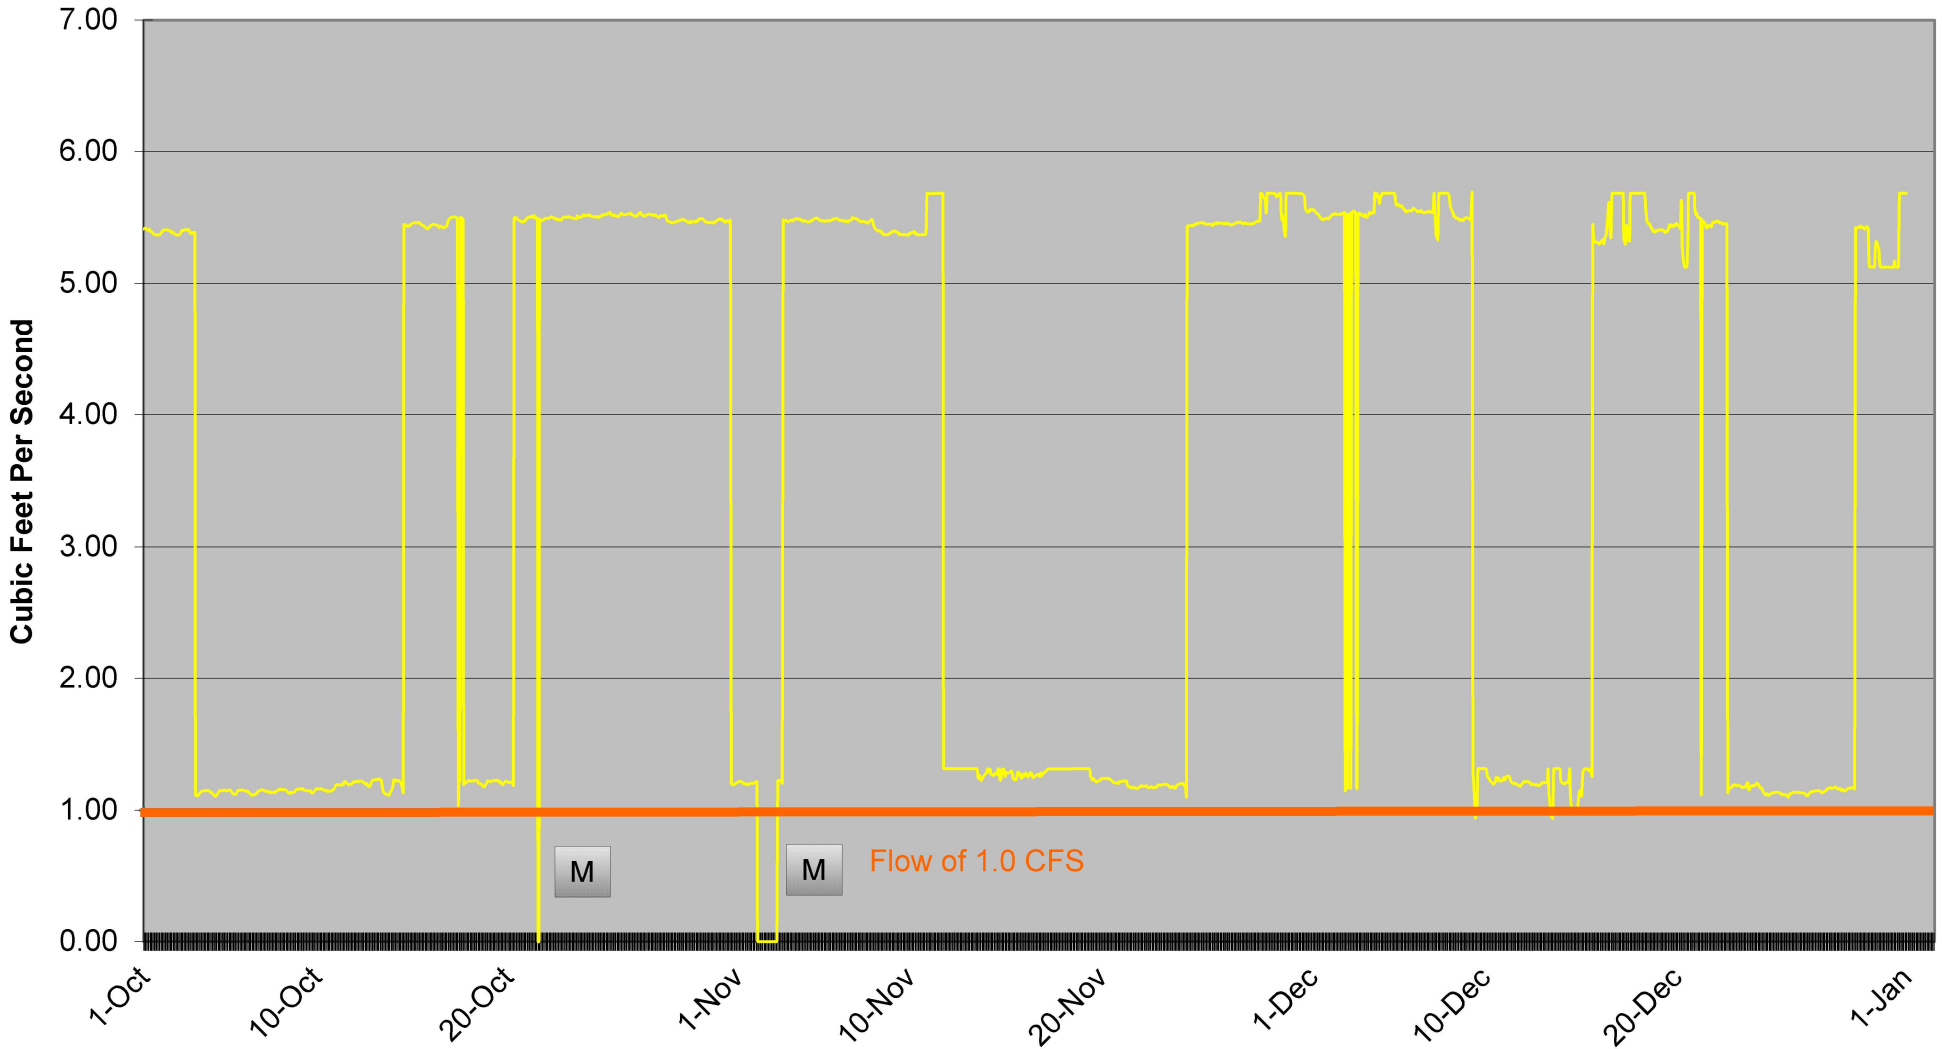
Maryville Quarry - Discharge Flow Meter 4th Quarter 2025

M = Pump Maintenance

— Discharge Flow Meter

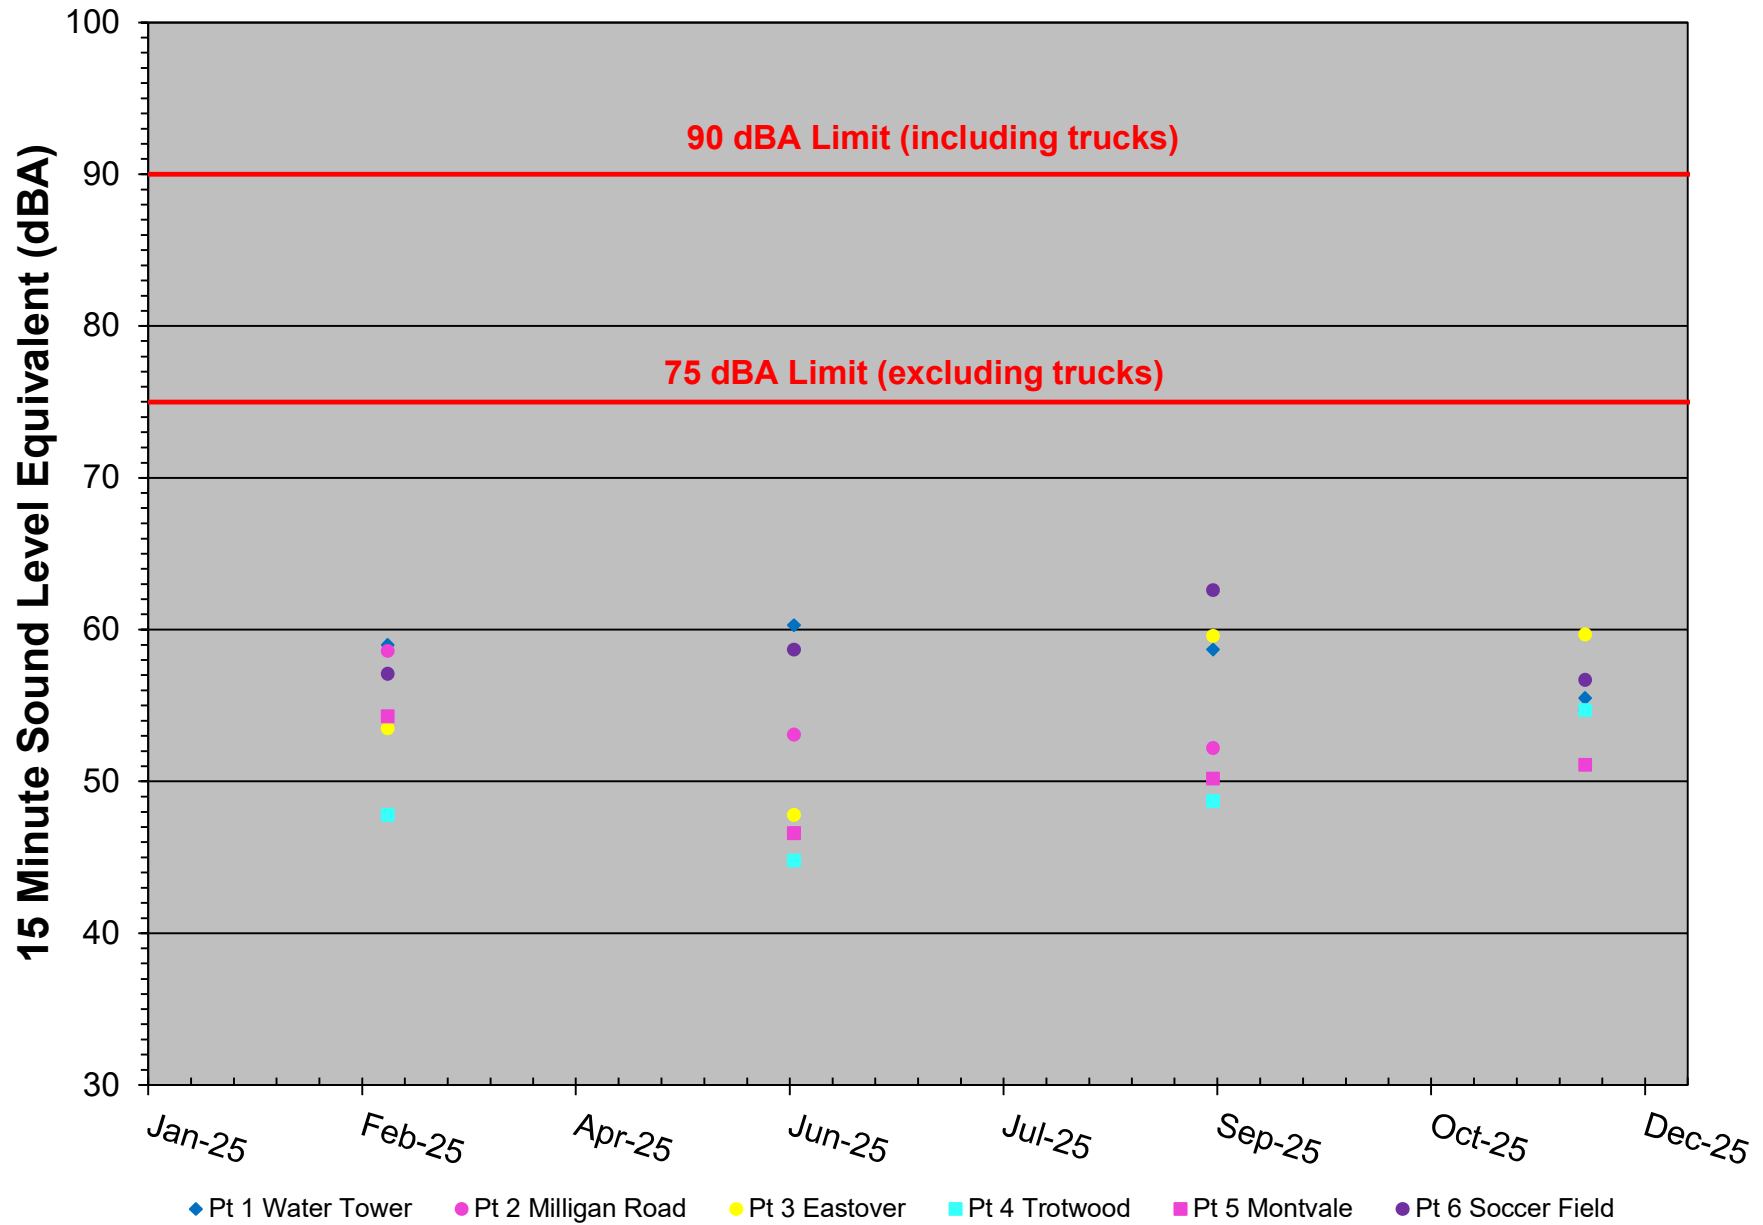
Maryville Quarry Noise Monitoring 2025

Sample Location	Latitude	Longitude	Date	Start Time	End Time	Avg. Wind Speed (mph)	Wind Direction	% Cloud Cover	Sound Level (15 min. avg. dB)	Fugitive Dust Observed (Y or N)

#1 Water Tower	N35 43 58.8	W83 57 01.8	2/28/2025	10:14	10:29	3	SW	0	59	N
			6/3/2025	7:44	7:59	2	WSW	0	60.3	N
			9/9/2025	8:29	8:44	2	E	85%	58.7	N
			12/5/2025	9:41	9:56	2	NE	100%	55.5	N

#2 Milligan Rd	N35 43 40.1	W83 56 46.2	2/28/2025	10:37	10:52	5	SW	0	58.6	N
			6/3/2025	8:07	8:22	2	W	0	53.1	N
			9/9/2025	8:47	9:02	2	E	90%	52.2	N
			12/5/2025	10:01	10:16	2	N	100%	54.7	N

#3 Eastover	N35 43 30.4	W83 57 18.4	2/28/2025	11:06	11:21	6	WSW	0	53.5	N
			6/3/2025	8:29	8:44	2	WNW	10	47.8	N
			9/9/2025	9:09	9:24	3	E	90%	59.6	N
			12/5/2025	10:23	10:38	3	N	100%	59.7	N

#4 Trotwood	N35 43 43.3	W83 57 35.8	2/28/2025	11:35	11:50	7	WSW	0	47.8	N
			6/3/2025	9:01	9:16	3	WNW	35	44.8	N
			9/9/2025	9:45	10:00	3	E	90	48.7	N
			12/5/2025	10:53	11:08	2	N	100%	54.7	N

#5 Montvale Rd	N35 43 53.8	W83 57 53.7	2/28/2025	11:53	12:08	7	SW	0	54.3	N
			6/3/2025	9:19	9:34	3	NW	30	46.6	N
			9/9/2025	10:03	10:18	3	NE	90	50.2	N
			12/5/2025	11:10	11:25	2	NNW	100%	51.1	N

#6 Soccer Field	N35 44 17.3	W83 57 13.4	2/28/2025	12:28	12:43	8	WSW	0	57.1	N
			6/3/2025	9:52	10:07	1	ENE	20	58.7	N
			9/9/2025	10:30	10:45	4	NE	95	62.6	N
			12/5/2025	11:35	11:50	2	NW	100%	56.7	N
