Report of Noise, Dust, and Blasting Monitoring
 Vulcan Materials Company
 Maryville Quarry

2024 Maryville Quarry Blasting Monitoring

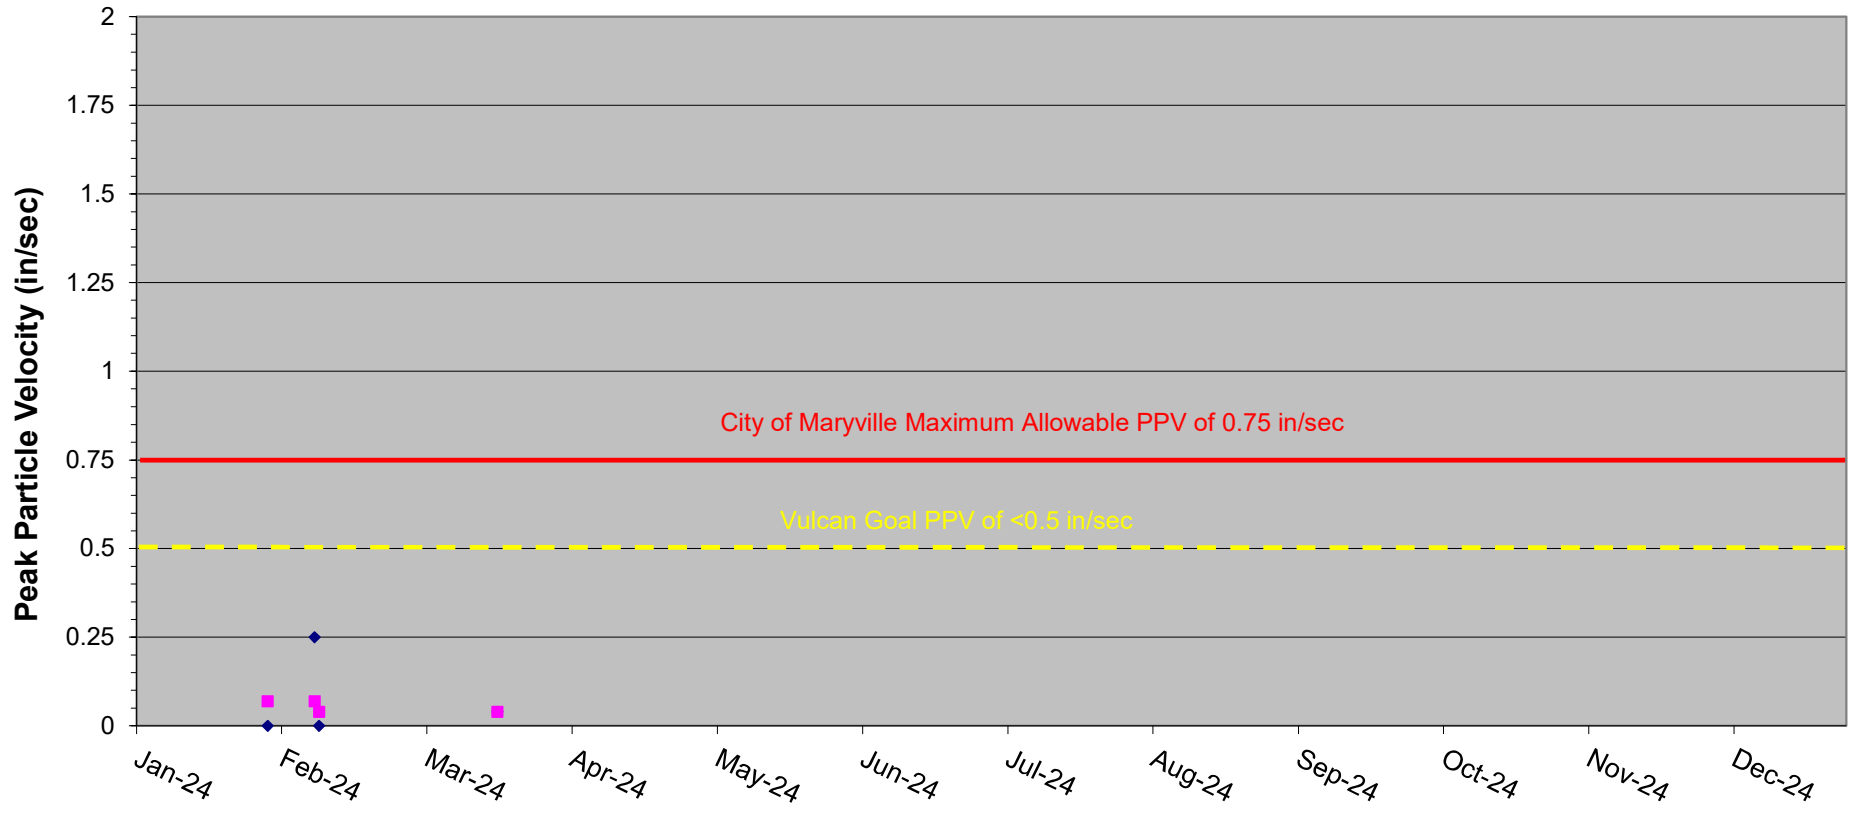
Maryville Quarry Blasting 2024

◆ Seismograph on Quarry Property ■ Seismograph at Garland Residence

Blast Date	Time	Seismograph Located on the Quarry Property (MontvaleRd)		Seismograph Located at 2020 Duncan Rd	
		PPV	dB	PPV	dB
1/29/24	15:32	NT	NT	0.07	102
2/8/24	13:52	0.25	116	0.07	124
2/9/24	14:06	NT	NT	0.04	109
3/18/24	13:06	0.04	110	0.04	117

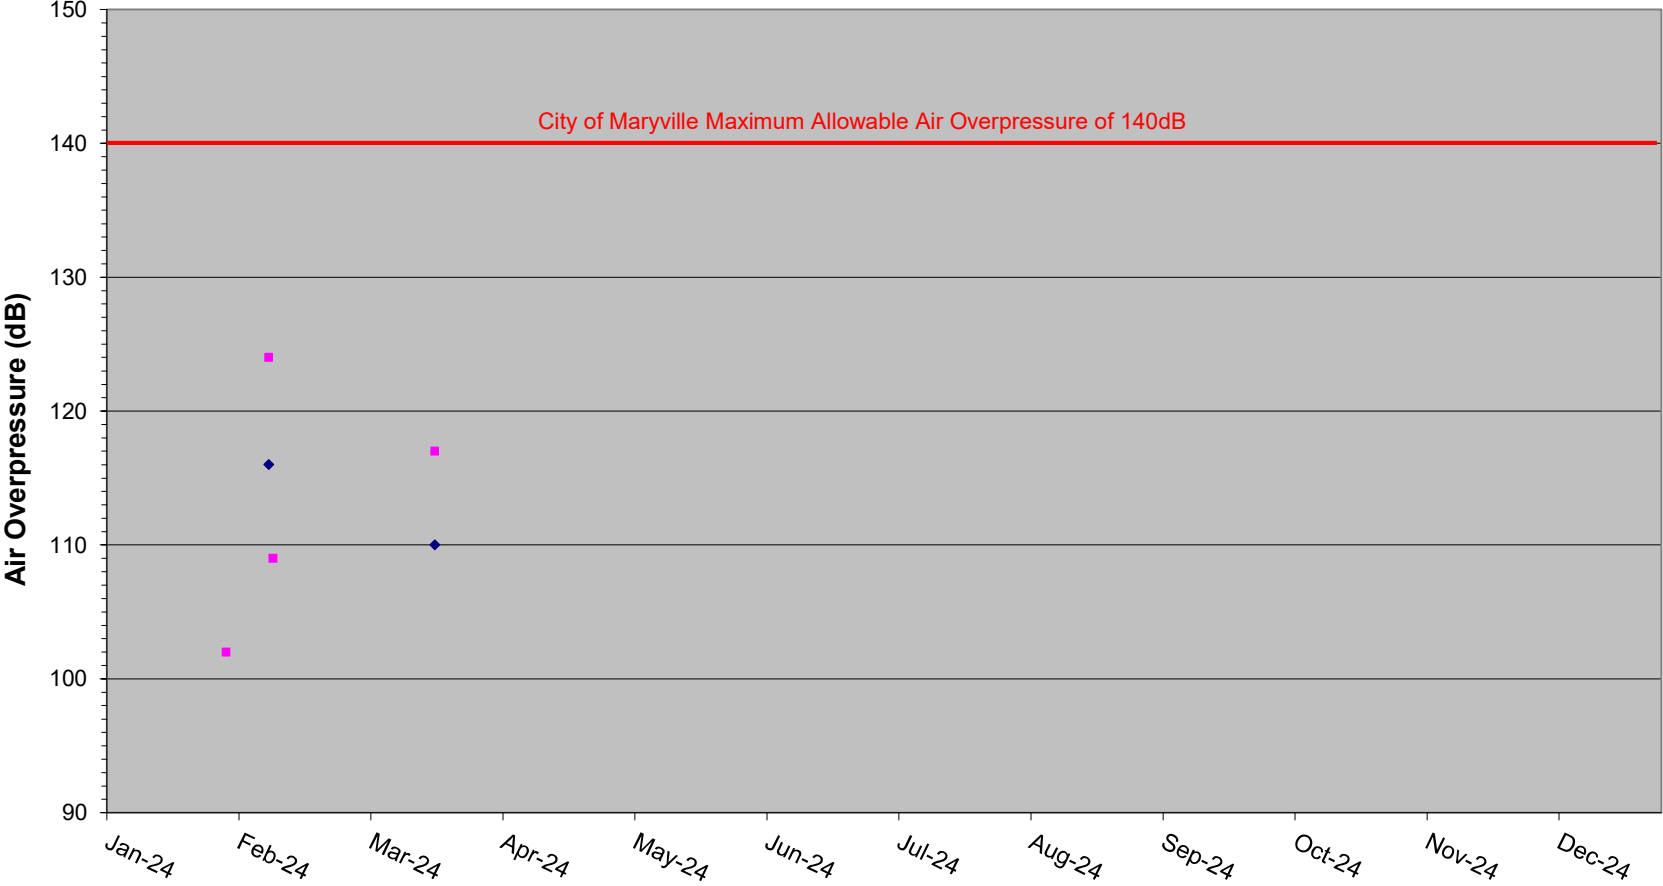
Maryville Quarry Blasting 2024

◆ Seismograph on Quarry Property ■ Seismograph at Garland Residence
